PENNSYLVANIA
LEVEL II
SAMPLE RUN DAM

NDI I.D. NO: PA-00284
DER I.D. NO: 32-14

PHASE I INSPECTION REPORT
NATIONAL DAM INSPECTION PROGRAM

SAMPLE RUN DAM
NDI I.D. PA-284
NOVEMBER 30, 1979

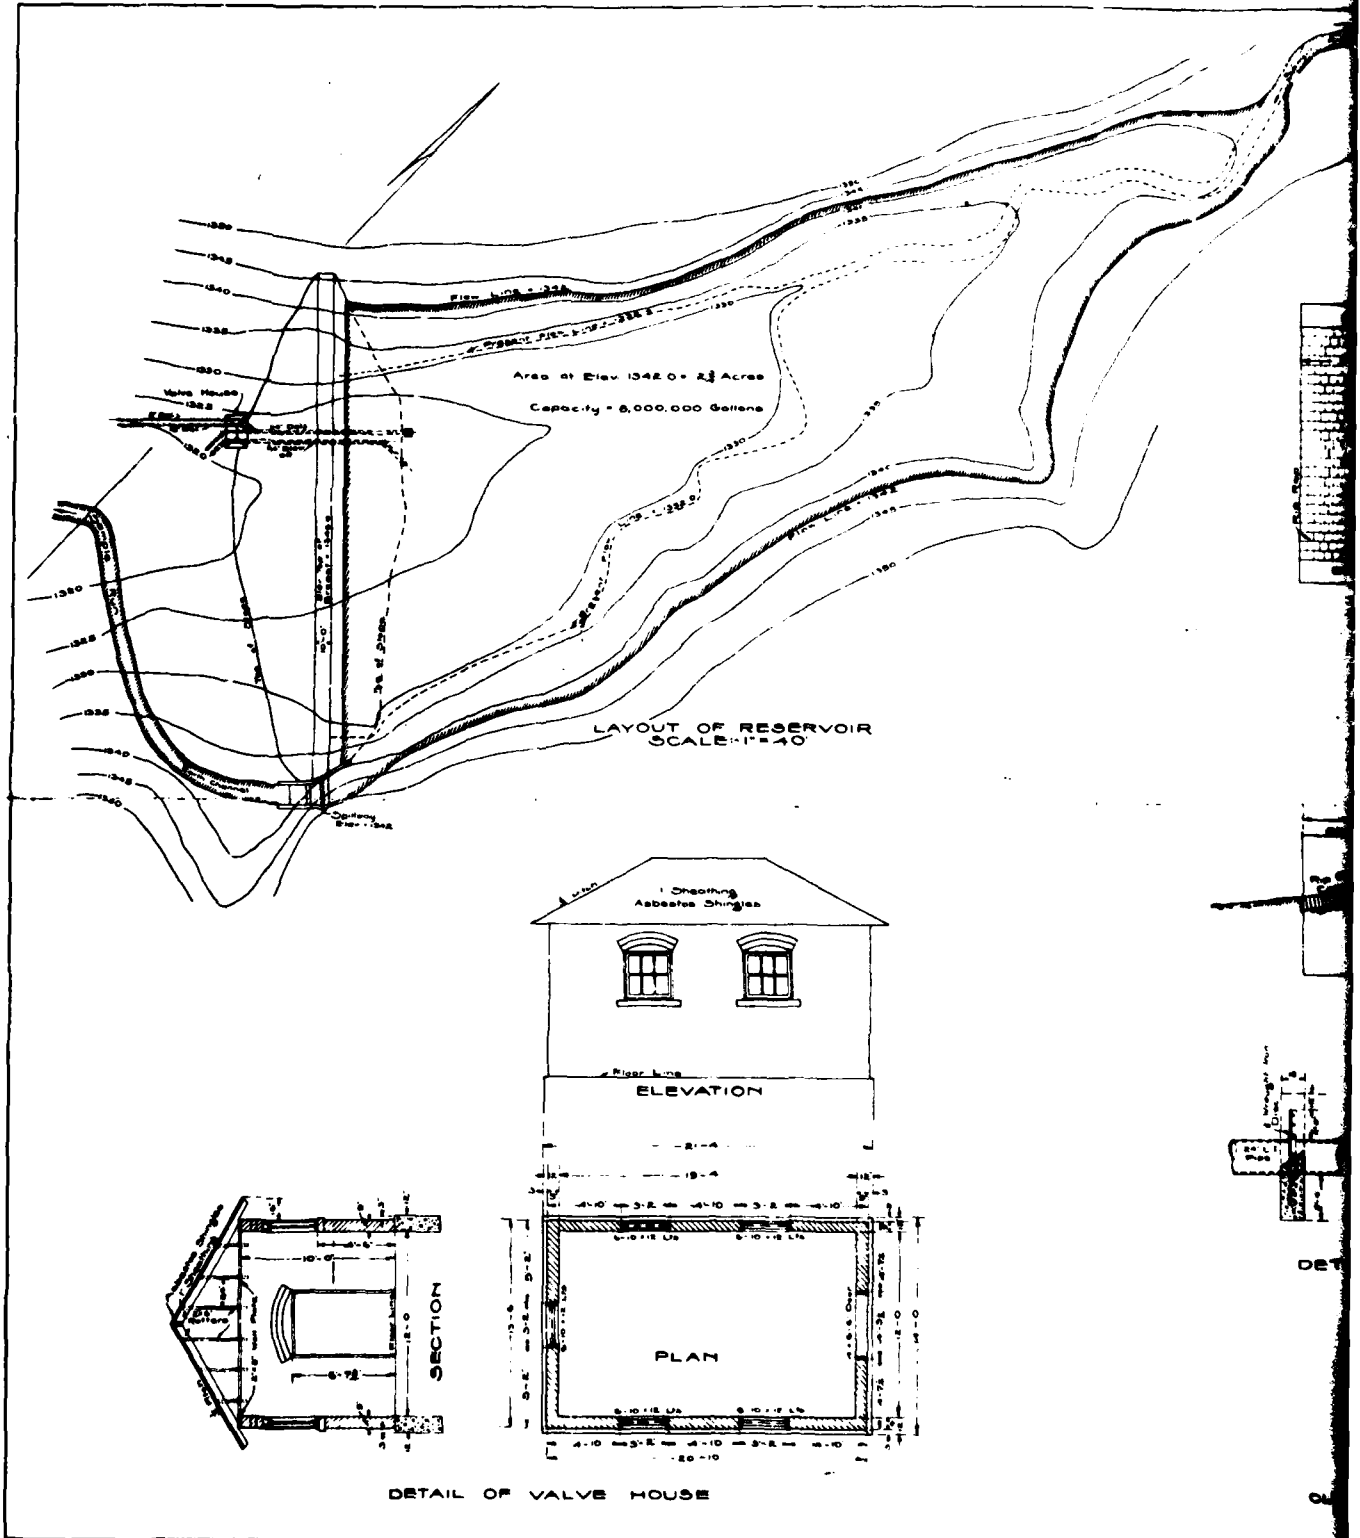
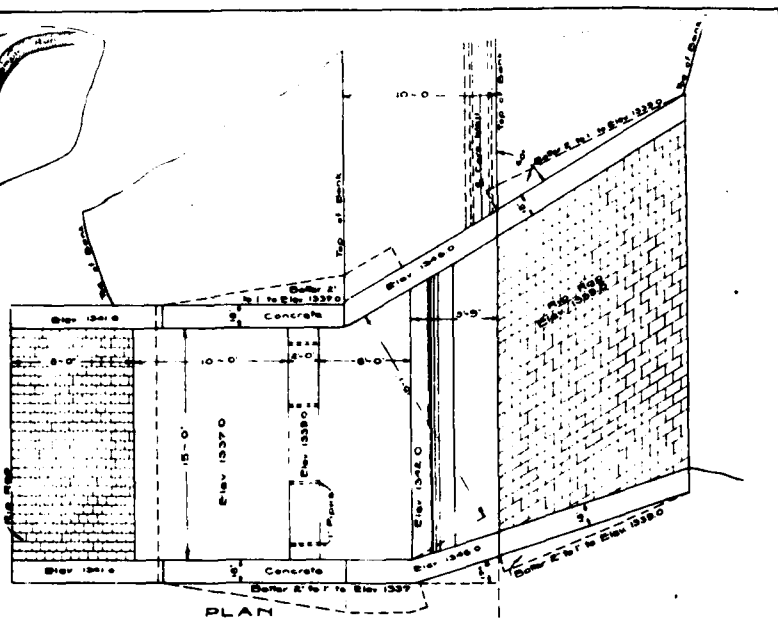
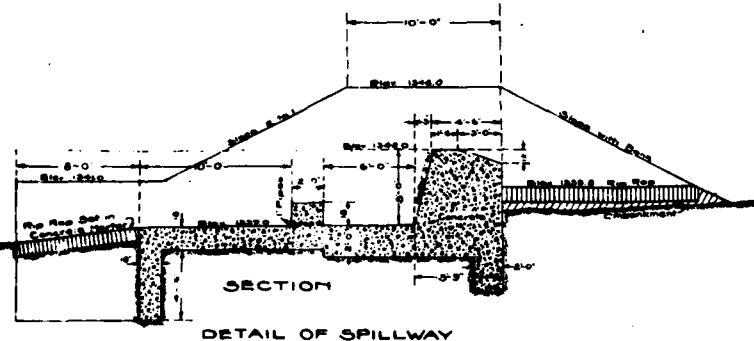
LAYOUT AND DETAILS
OF RESERVOIR
FOR POWER PLANT
CLYMER, PA.
CLEARFIELD BITUMINOUS COAL CORP'n
SCALE - $\frac{1}{2}'' = 1'$ MCH. 1916

The outlet facilities consist of low- and high-level supply pipes and a reservoir blow-off pipe. The layout of the reservoir blow-off pipe and low-level supply pipe is illustrated in Plate 3. Both pipes consist of 24-inch cast-iron pipes founded on concrete cradles. As shown in Plate 4, the pipes are equipped with wrought iron cutoff collars encased in concrete. It appears that the 16-inch high-level intake pipe was constructed during the enlargement of the dam in 1930. As it presently exists, this high-level intake pipe receives flow from an intake structure located on the upstream side of the dam, about 100 feet from the right abutment, and discharges into an earth channel about 50 feet from the toe of the dam. As illustrated in Plate 3, flow through the reservoir blow-off pipe and low-level supply pipe is controlled by valves located in the valve house.
